**City of Los Angeles
WATERSHED PROTECTION DIVISION
ENVIRONMENTAL ENFORCEMENT & EMERGENCY RESPONSE UNIT**

CASE #52967

Spill/Fire Investigation

Case #52967 – 210 W Slauson Ave – fuel spill and tanker fire
Prepared by Environmental Compliance Officer Cook

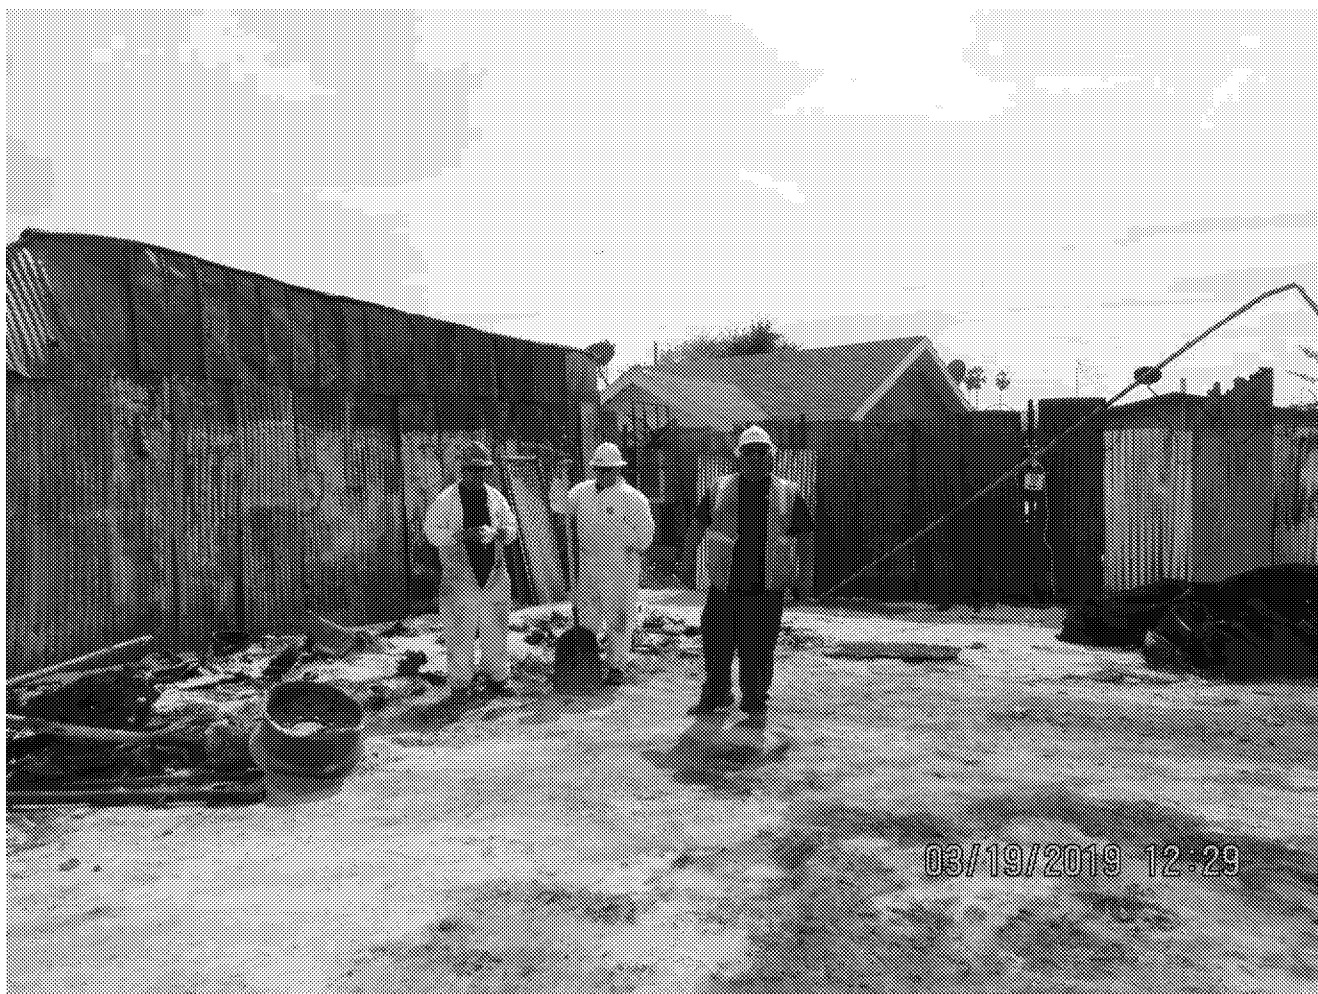
Figure #53.

Day after the incident. View facing southeast at 210 W Slauson Ave, Parcel A, after removal of "tanker." White substance is absorbent placed on ground by CHES.

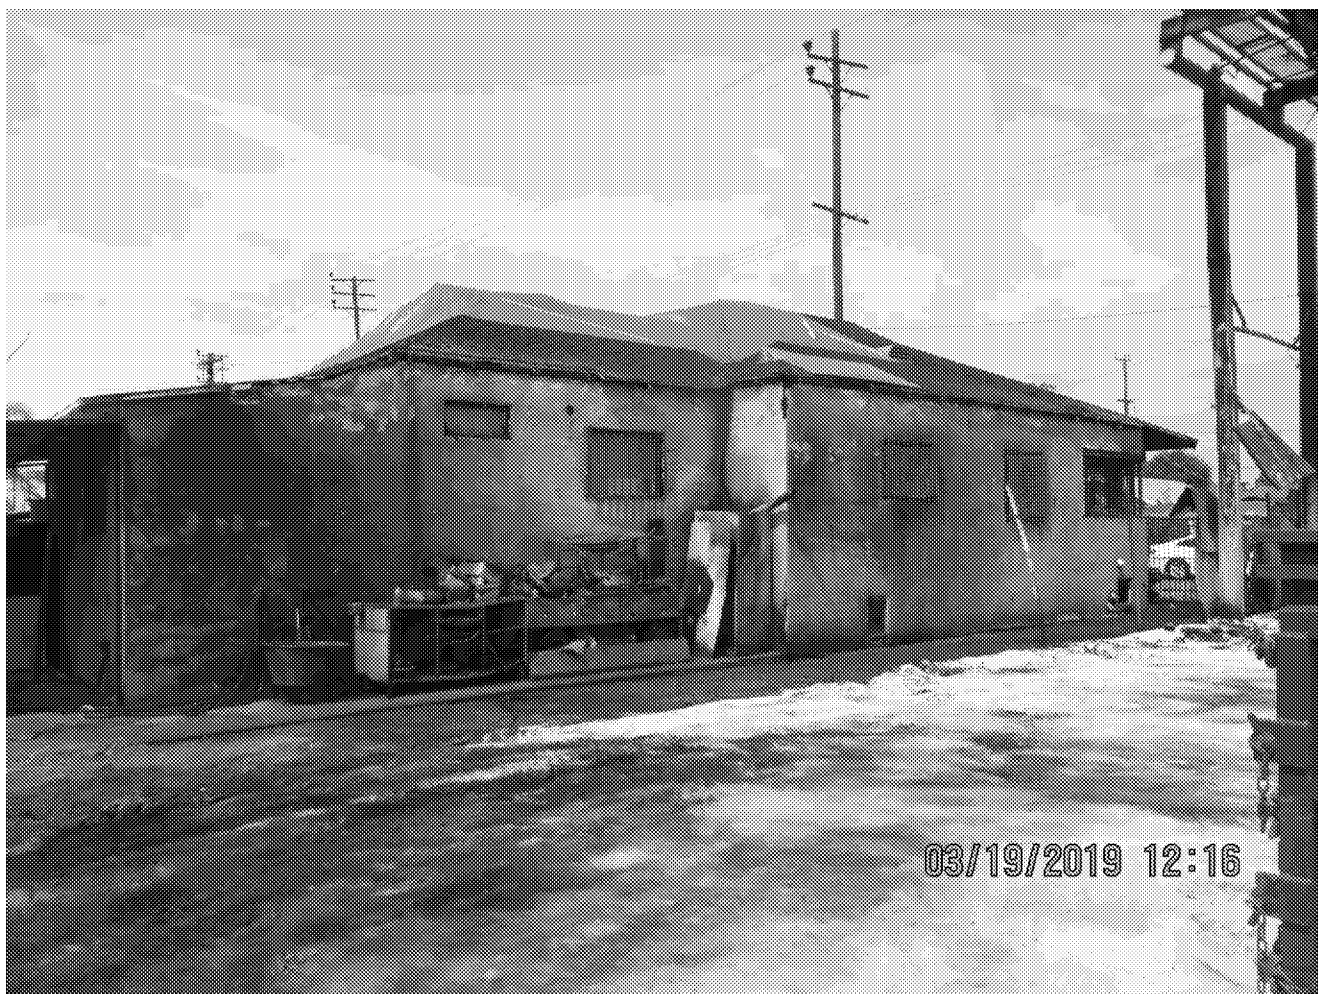
Figure #54.

View facing northwest of home at 216 W Slauson Ave, the day after the incident. White substance is absorbent placed on ground by CHES.

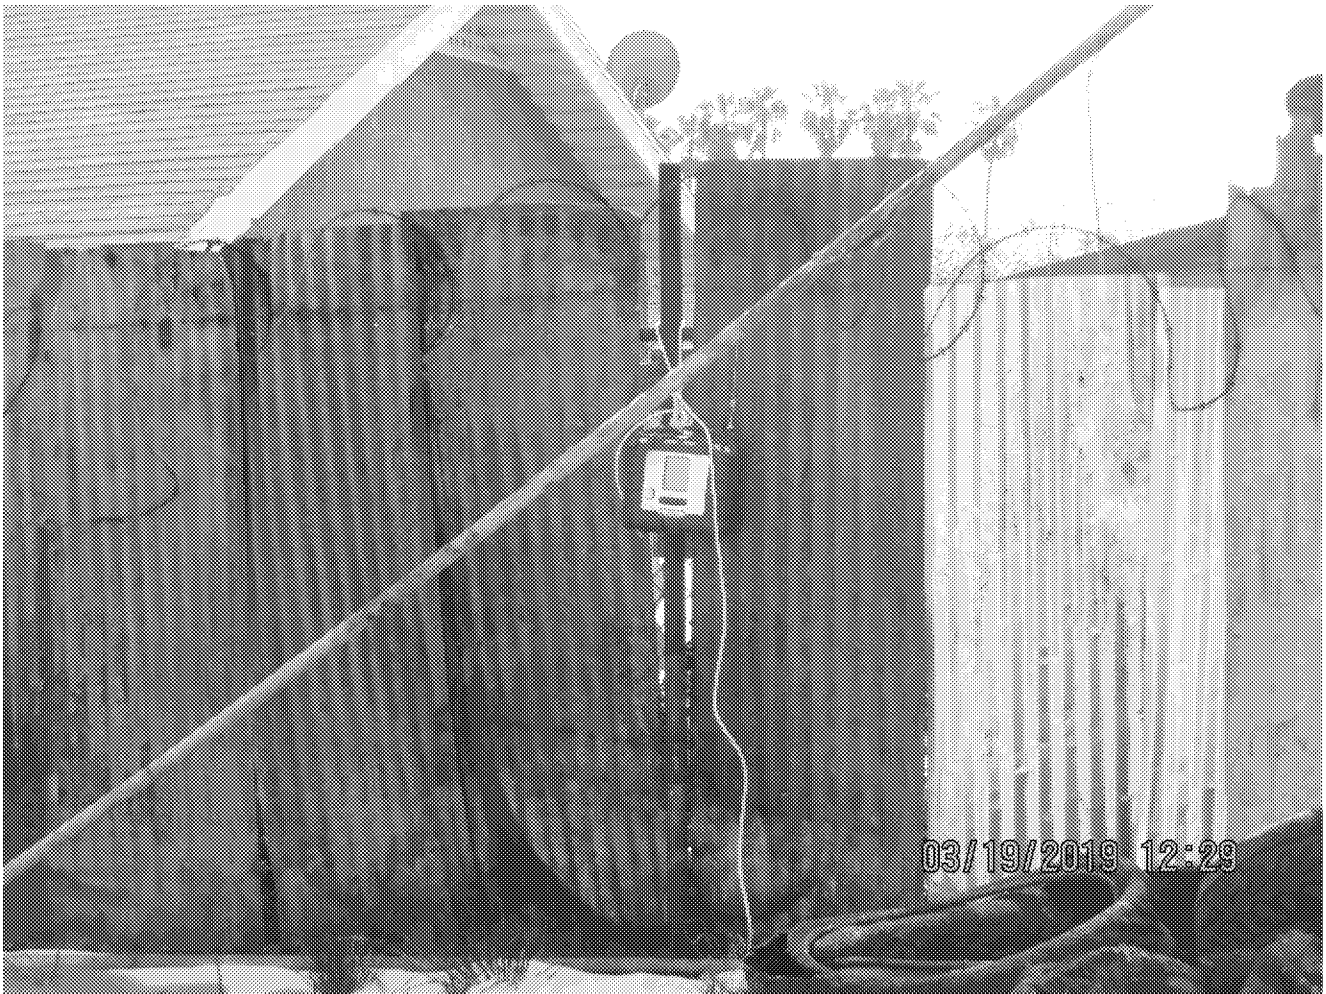
Figure #56.

View facing south at 210 W Slauson Ave, Parcel A, with a USEPA air monitor attached to the fence.

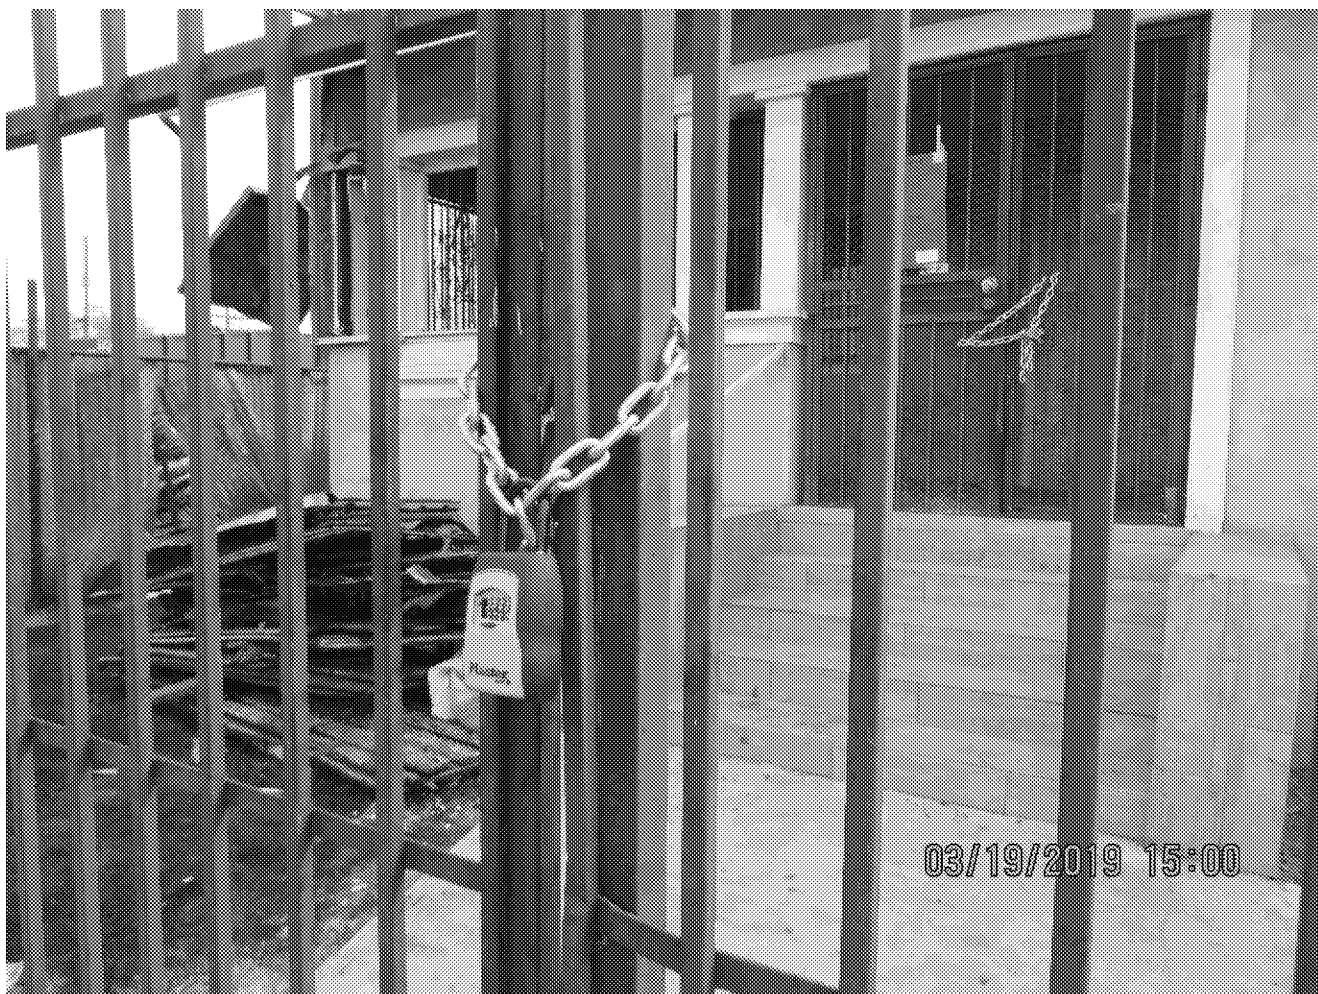
Figure #57.

View facing southeast of locked property at 216 W Slauson Ave with fire-damaged wood on the ground. Red notice taped on home door states "Unsafe, do not enter or occupy by order of the City of Los Angeles," in English and Spanish.

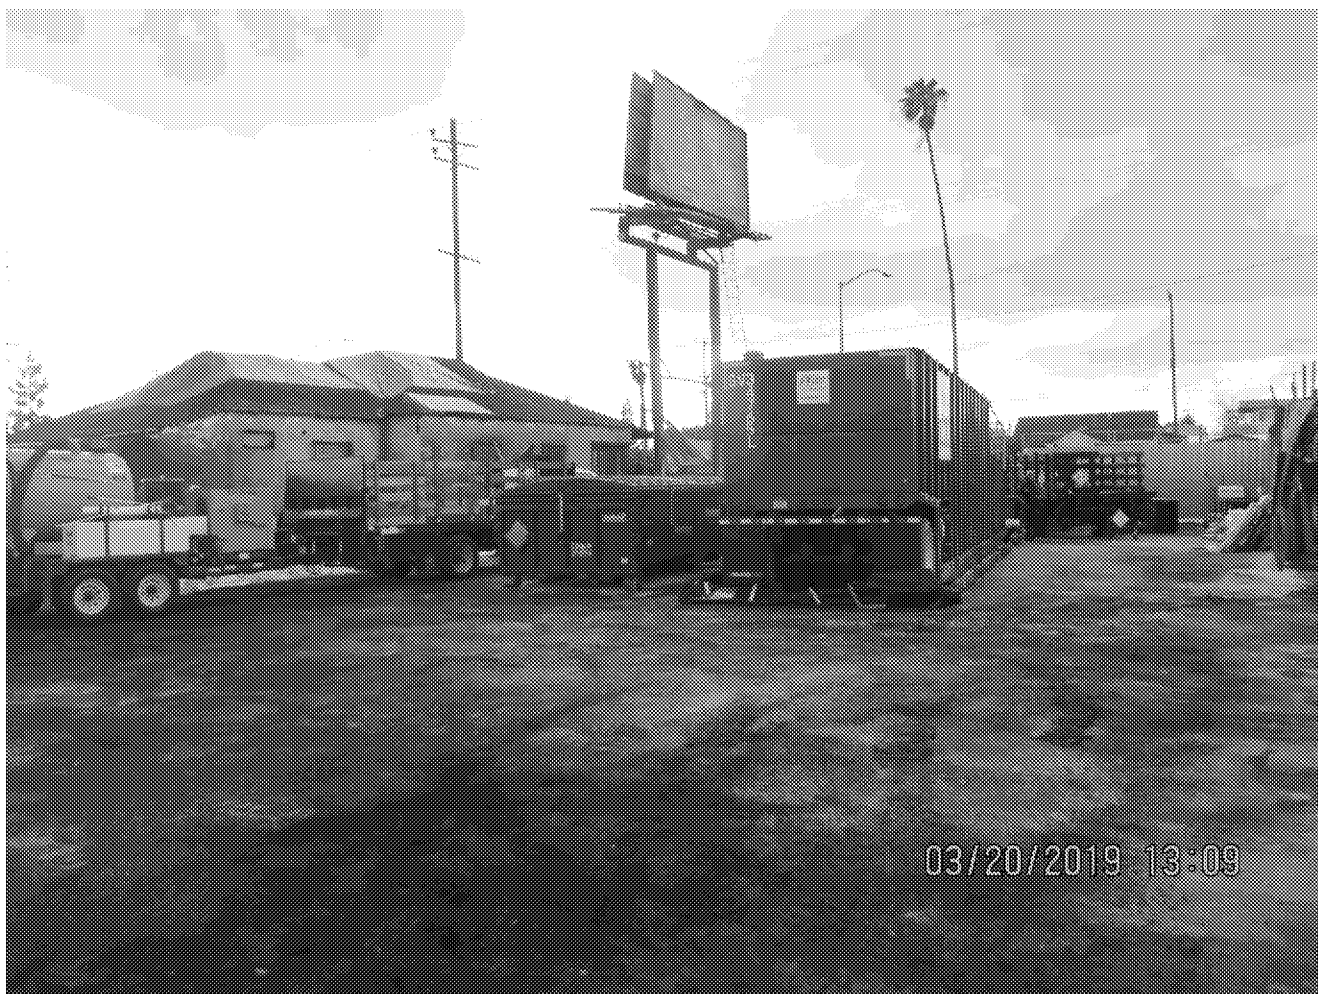
Figure #58.

View facing northwest at 210 W Slauson Ave, Parcel A, two days after the incident. CHES and their vehicles and equipment on site.

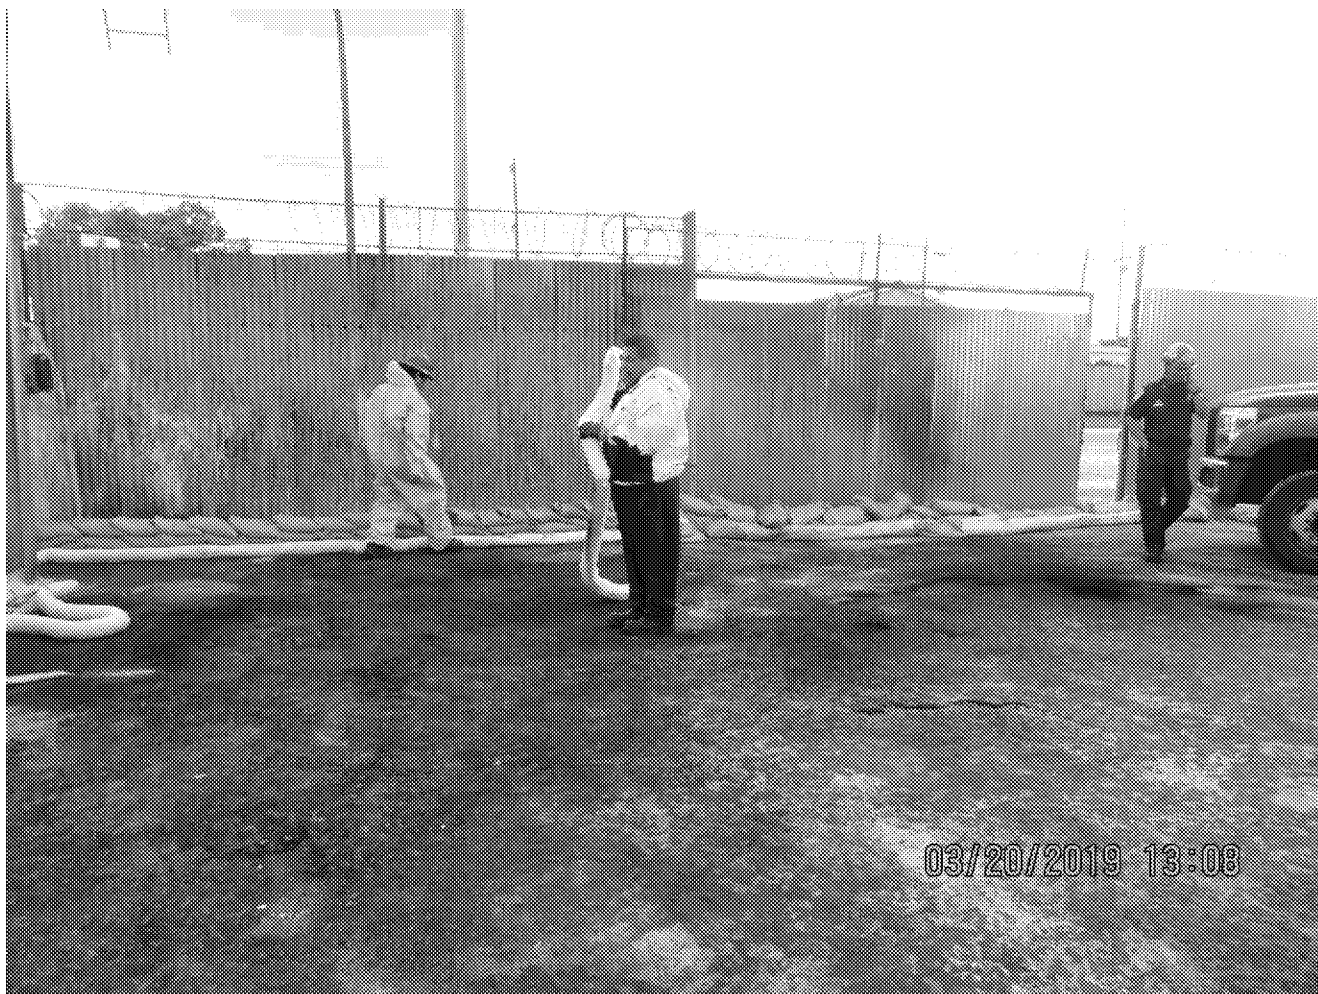
Figure #59.

View facing northeast at 210 W Slauson Ave, Parcel A. Rainfall event occurring in photo. CHES Environmental Technicians pictured barricading the property with sand bags and booms for pollution containment from discharging to the public right-of-way.

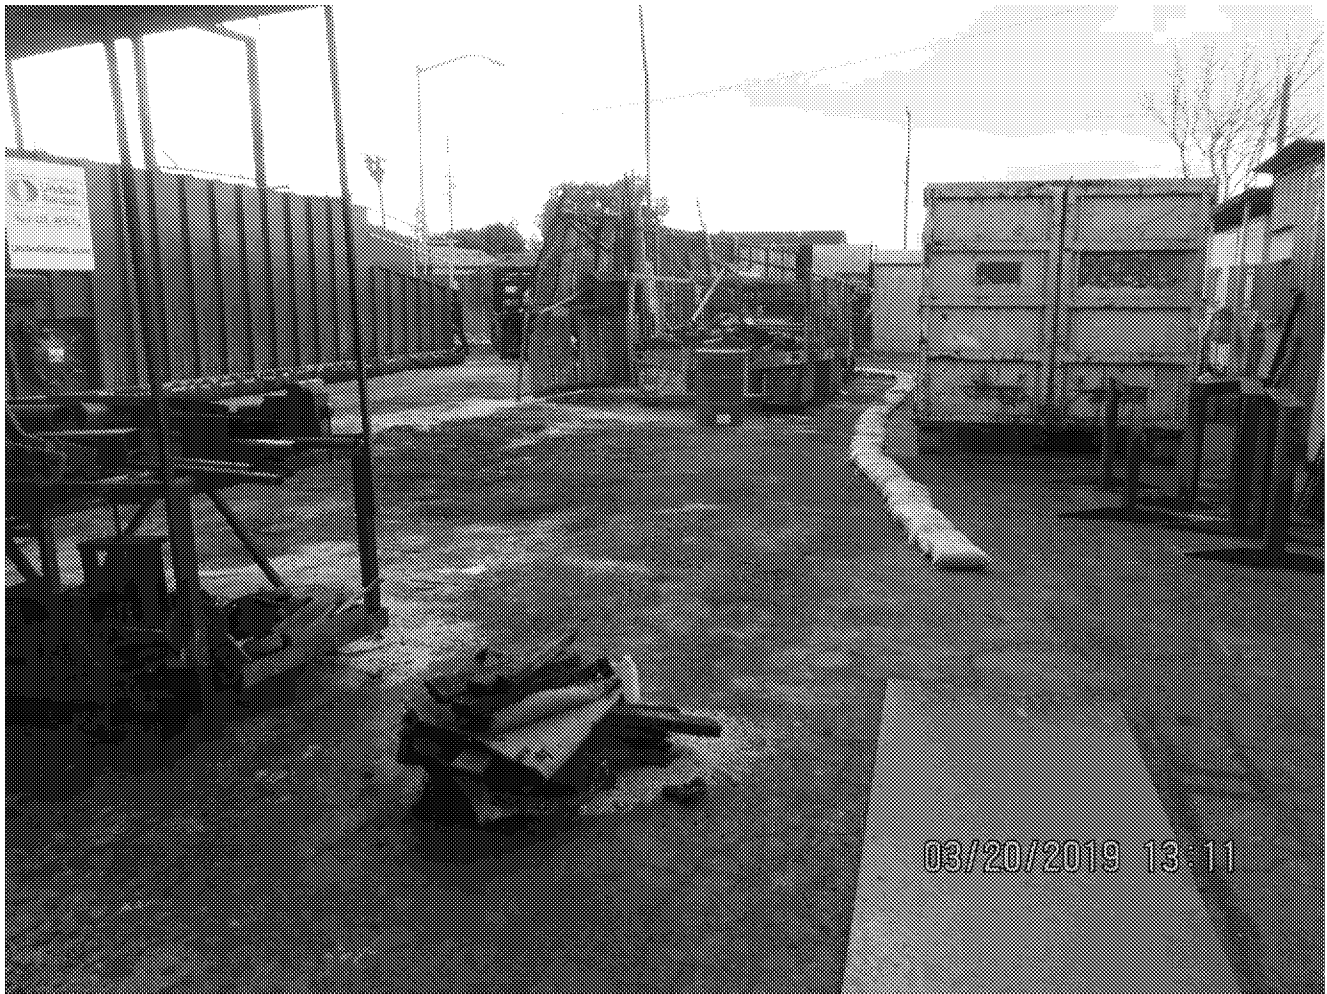
Figure #60.

View facing northwest at 210 W Slauson Ave, Parcel B. Rainfall event occurring in photo. Sandbags placed on ground by CHES. Portions of fire-damaged fencing separating Parcel A from Parcel B removed by CHES.

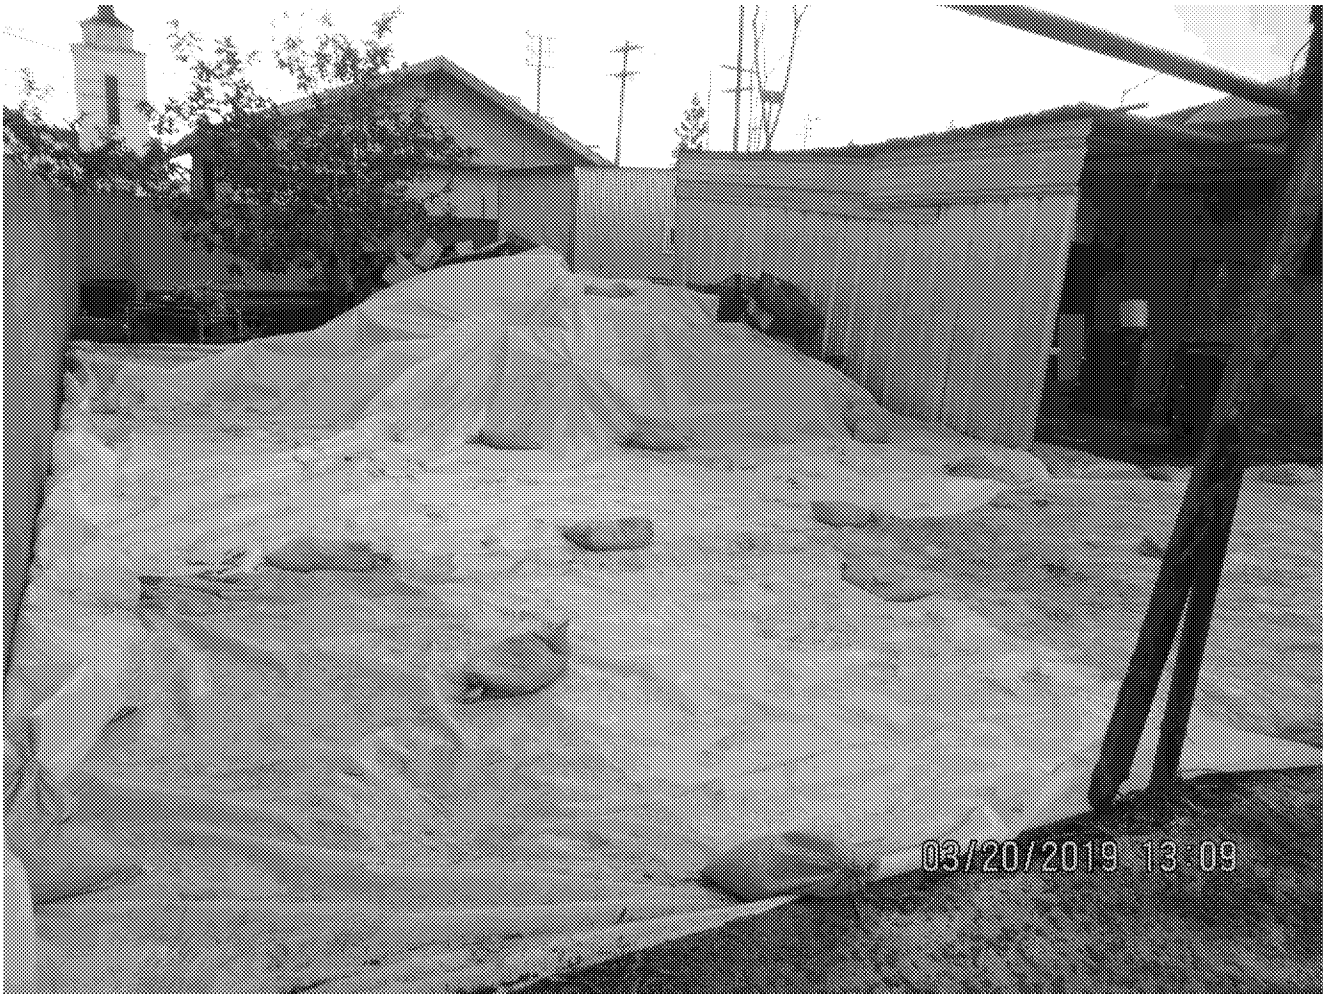
Figure #61.

View facing northwest at backyard property of 216 W Slauson Ave. Rainfall event occurring in photo. Sandbags and polyethylene plastic sheeting (also known as “visqueen”) placed on ground by CHES to contain pollutants from discharging to the public right-of-way. Portions of fire-damaged fencing separating Parcel A from Parcel B removed by CHES.

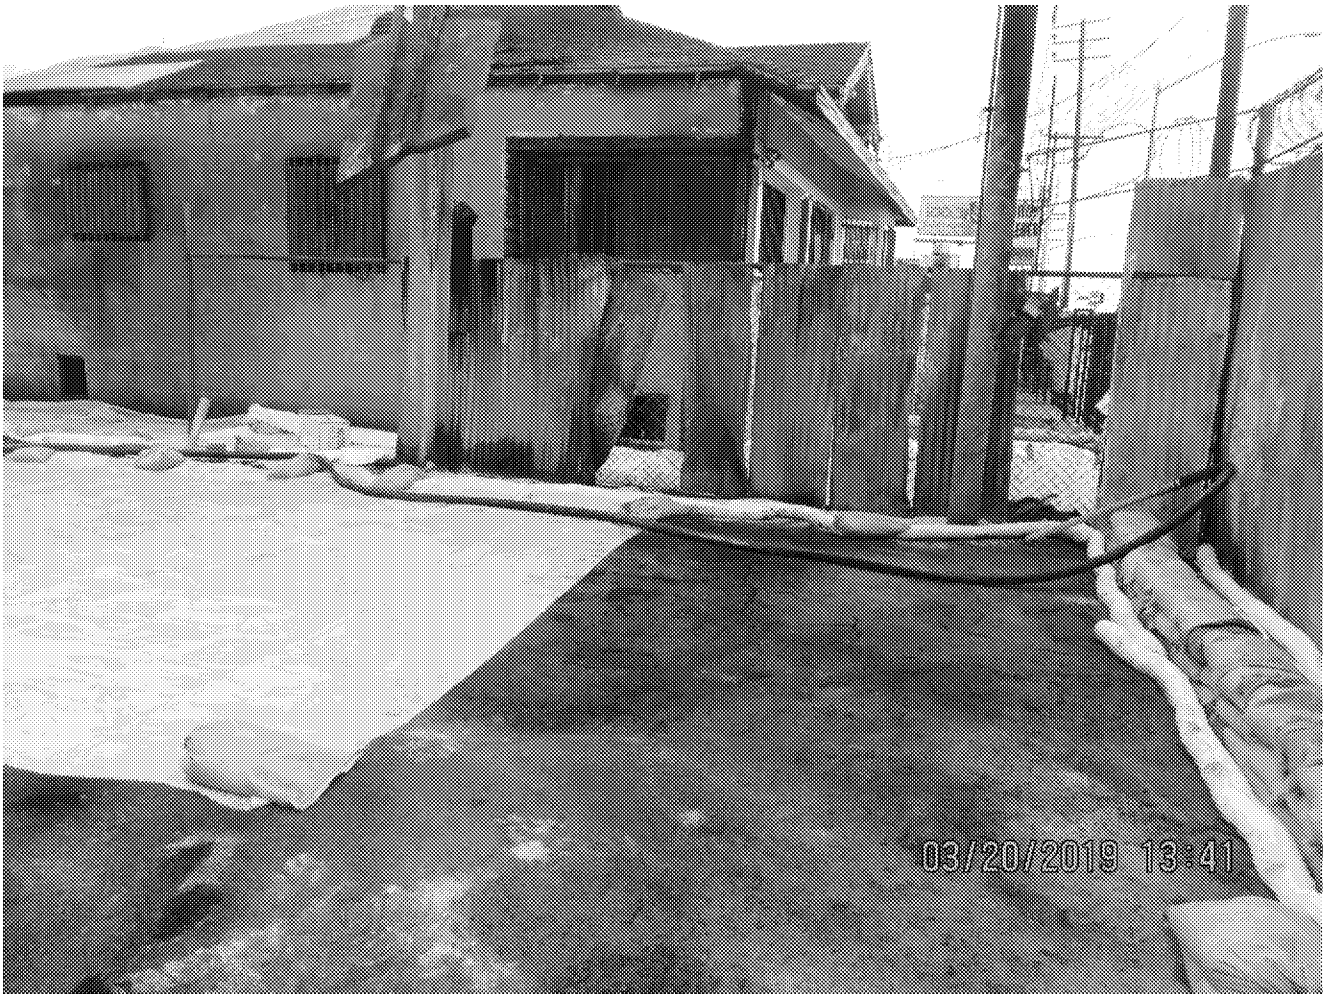
Figure #62.

View facing west at 210 W Slauson Ave, Parcel A. Rainfall event occurring in photo. Sandbags and polyethylene plastic sheeting (also known as “visqueen”) placed on ground by CHES to contain pollutants from discharging to the public right-of-way.

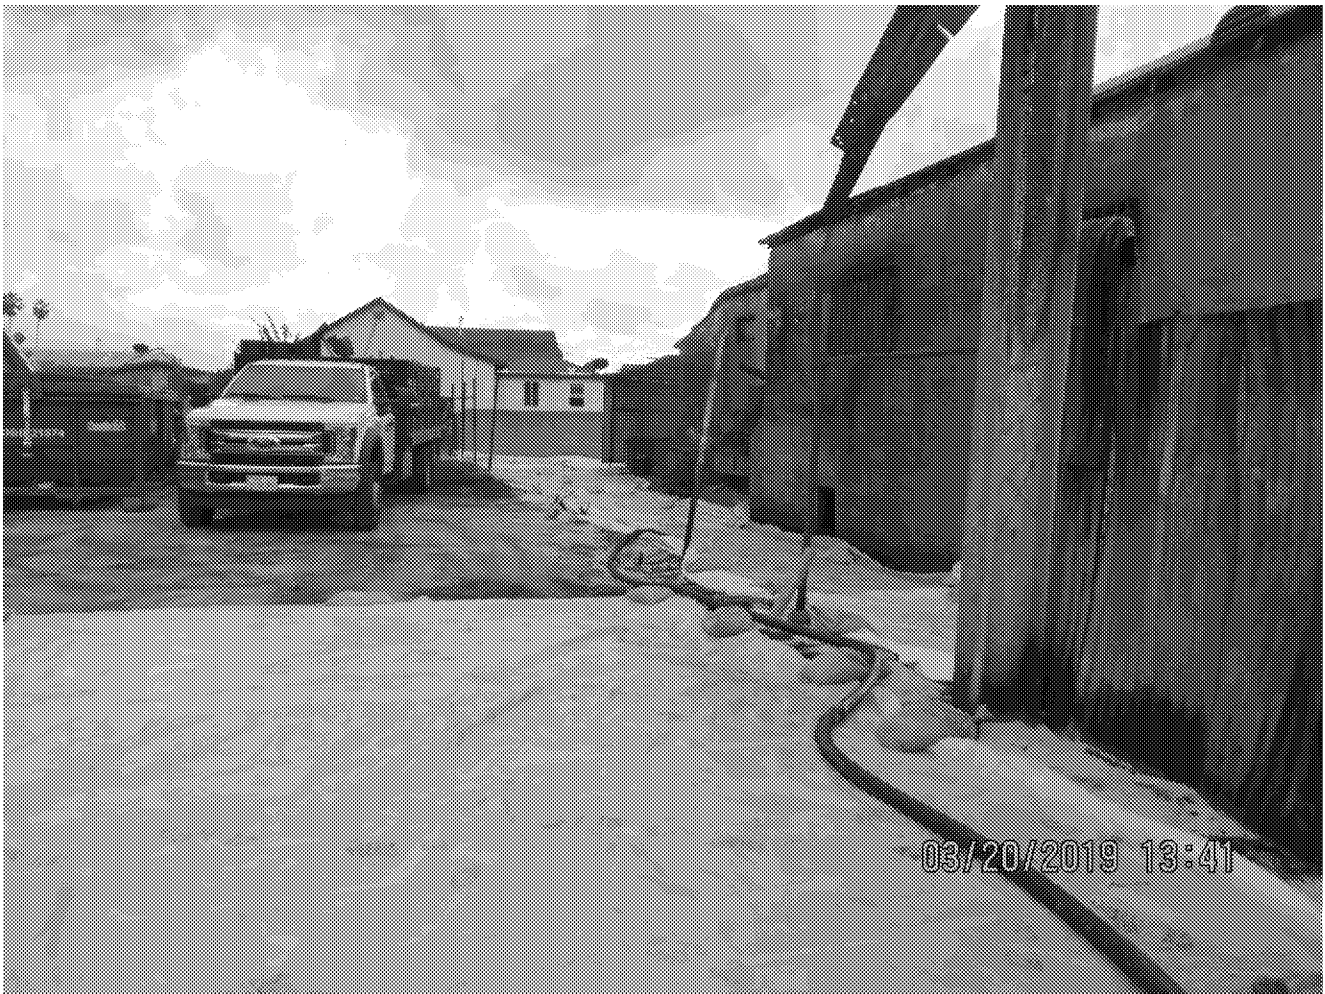
Figure #63.

View facing south at 210 W Slauson Ave, Parcel A. Rainfall event occurring in photo. Sandbags and polyethylene plastic sheeting (also known as “visqueen”) placed on ground by CHES to contain pollutants from discharging to the public right-of-way.

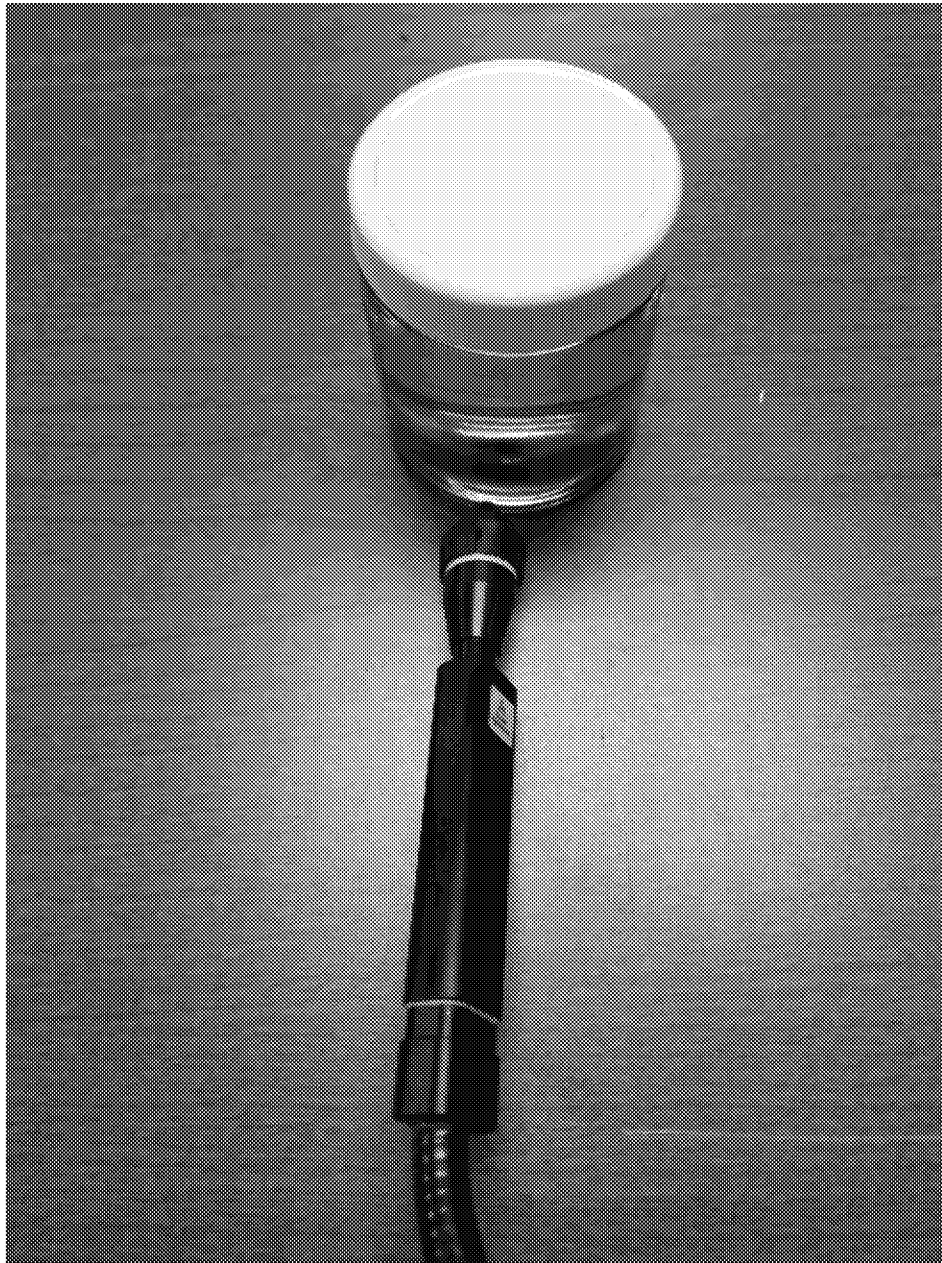
Figure #64.

Chemical identification analyzer (Thermo Scientific First Defender RMX brand) probing a source sample taken by WPD Lt. Lee from inside the “tanker” on March 17, 2019.

On March 20, 2019, at approximately 1625 hrs, WPD Lt. Lee used a chemical identification analyzer (Thermo Scientific First Defender RMX brand) to probe the outside of one of his liquid source samples he collected from the tank at 210 W Slauson Ave. The result read "Gasoline" (see Figures 64 and 65).

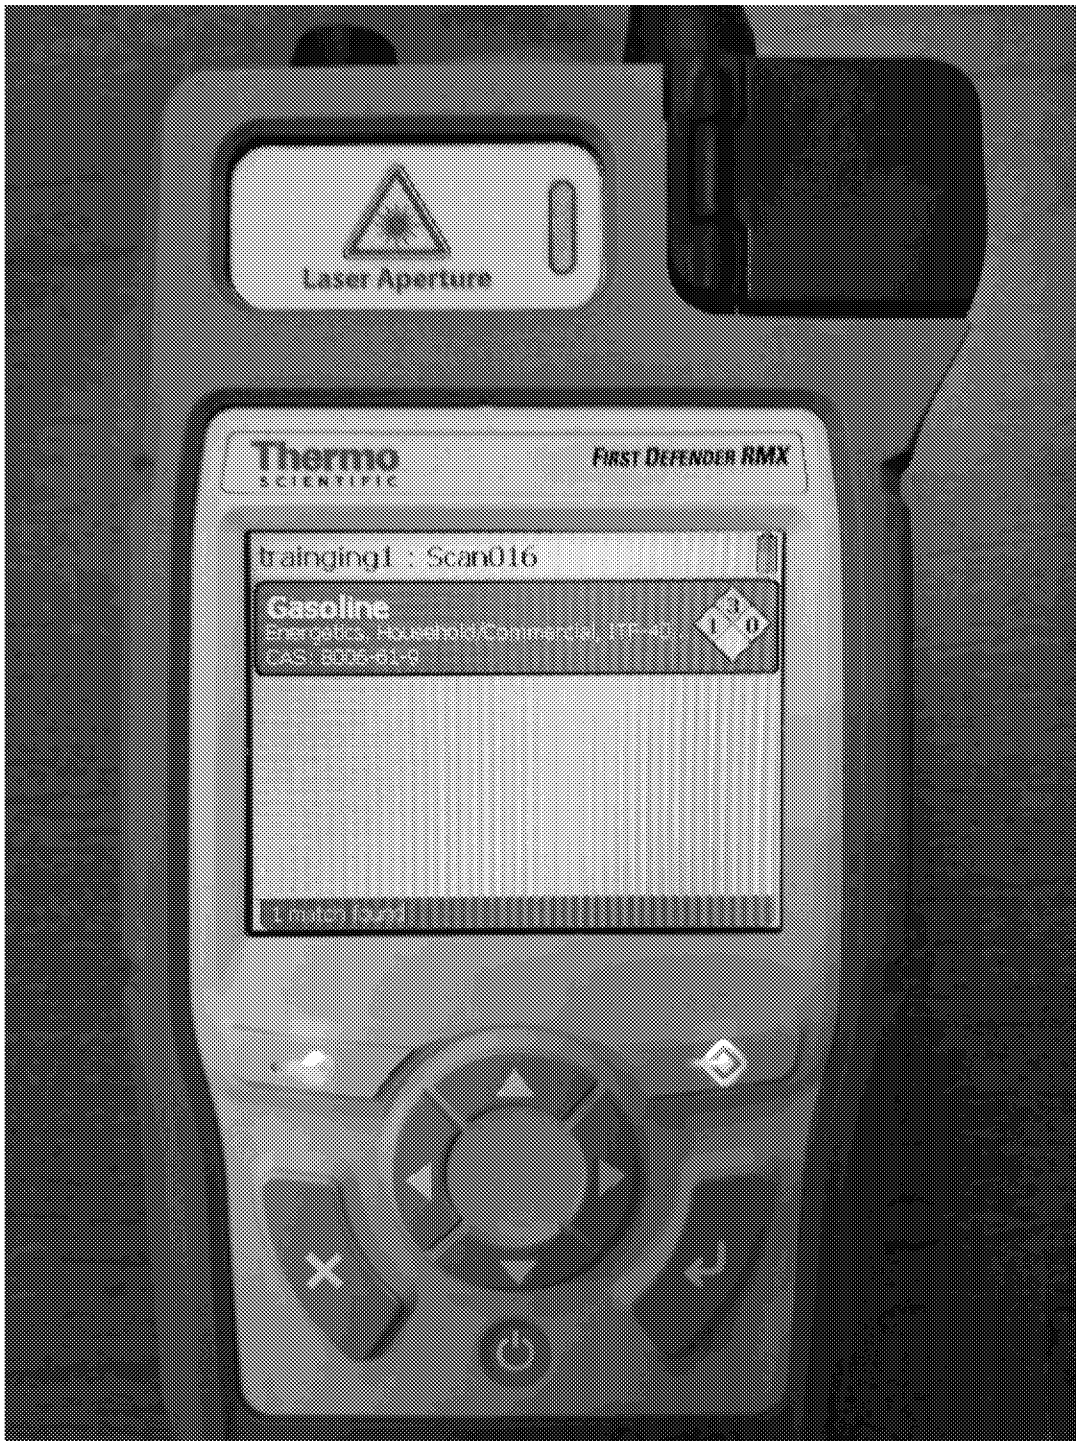
Figure #65.

Chemical identification analyzer (Thermo Scientific First Defender RMX brand) identifying the source sample taken by WPD Lt. Lee from inside the “tanker” on March 17, 2019 as “Gasoline.”

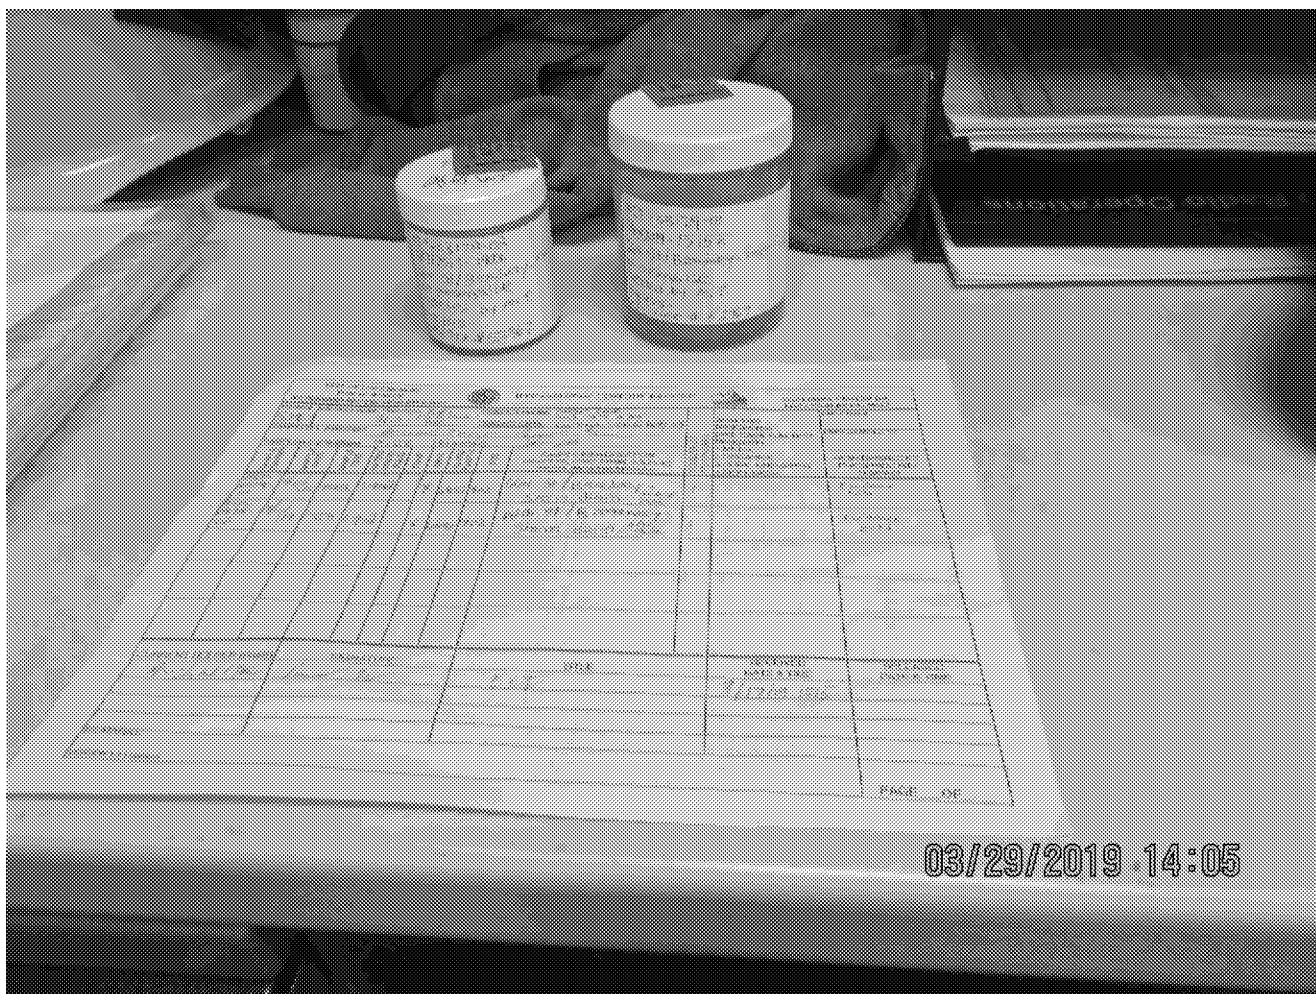
Figure #66.

Labeled and sealed storm drain samples #MIT-031719-01 and #MIT-03171902 along with chain of custody form for the two samples.
